**REPORT ON  
KOMENDA SUGAR  
FACTORY**

## REPORT ON THE KOMENDA SUGAR DEVELOPMENT COMPANY LIMITED

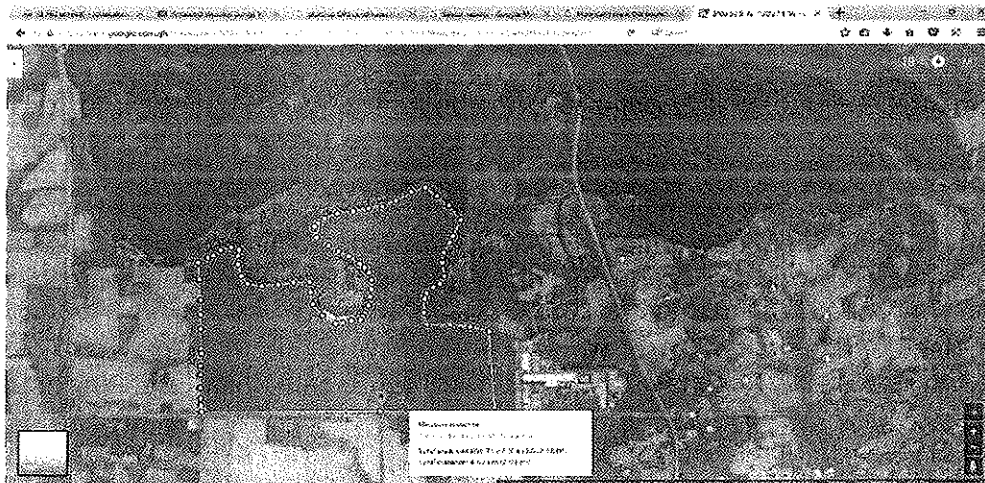
Fig. 1: Total area of Cane Nursery

24. The total fenced area earmarked for the nursery development is 63.4 Ha (158 acres). The Cropped area is 49.94Ha and out of this, 0.5ha is saline. The remaining land area is covered by the roads in the nursery. Some of the plants showed stunted growth and empty patches. There was a wide variation in the height of sugarcane on the same plot. The empty spaces were not filled thus reducing the expected plant population per hectare. However, other parts of the nursery showed strong and vigorous growth. It should be noted that none of the sugarcanes in the plots can be planted as plant cane this year since the planting date (May-June-July) is already past.

25. About 97% (48.8ha) of the cropped area is composed of the B41227 variety which is prevalent in the Komenda area. Investigations show that no variety selection was conducted since a period of 7-8 months was given as the duration for the nursery operation which was not enough for proper crop selection. Brix levels which were taken at the time of the study, the B41227 variety was 17.5% whiles, CO2014-001, CO86032, KI, K2 had brix levels of 22.5%, 19.1%, 21.8%, 21.6%, respectively.
